Cisco TelePresence System C/SX/EX/MX/Profile Series

Software release notes TC6

D1501708

September 2013

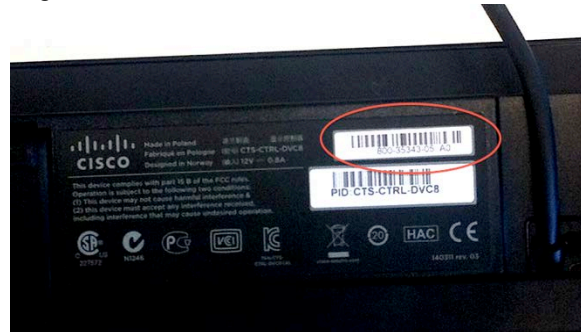
The TAN number can be found on the back of the Cisco TelePresence Touch 8 panel on the sticker positioned in the upper right corner.

There are as of TC6 four hardware levels of the Touch 8. The new hardware levels 1, 2 and 3 require newer software. From TC5.1.3 there is a lock preventing a downgrade of a system to a software version that is not supported by the connected touch panel.

Identify the minimum software supported by using the TAN number with this table.
